# THE NEED FOR ROOFS TO BREATHE

RICHARD OXLEY

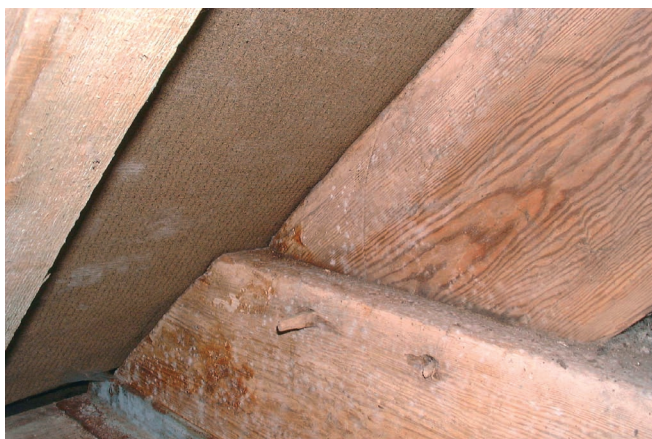
*Dampness and mould growth on a tie beam caused by the use of impervious roofing felt*

upon which warm moist air can condense. In these circumstances the rafters in contact with the felt may remain damp most of the time, causing the surface of the rafter to become stained and, in the worst case, rotten – as illustrated below.

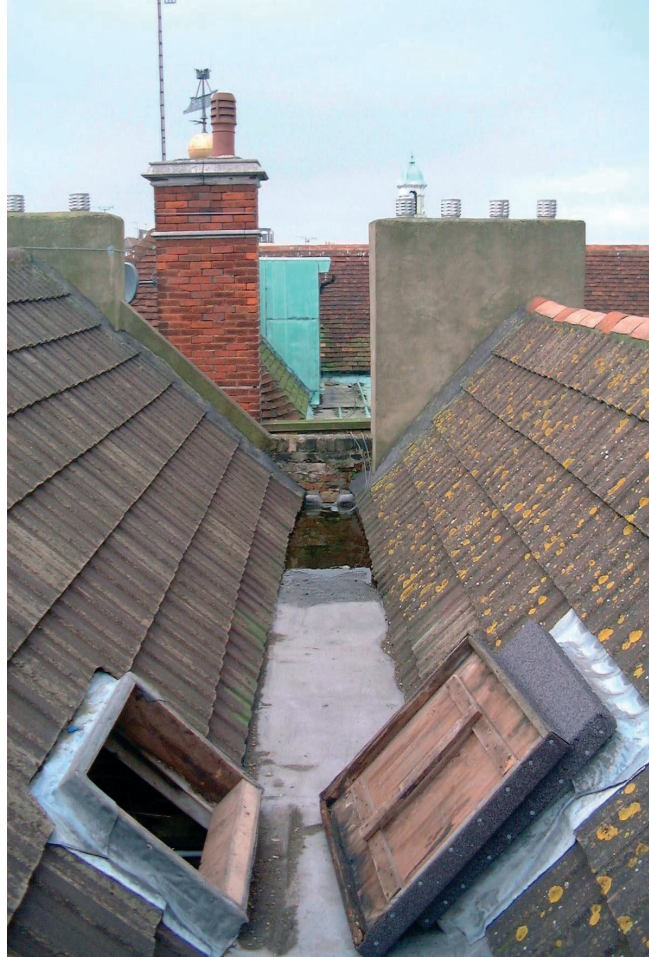
*Internal valley gutters are a perennial concern as their drainage is vulnerable to blockage by leaves in the autumn and snow in the winter in particular*

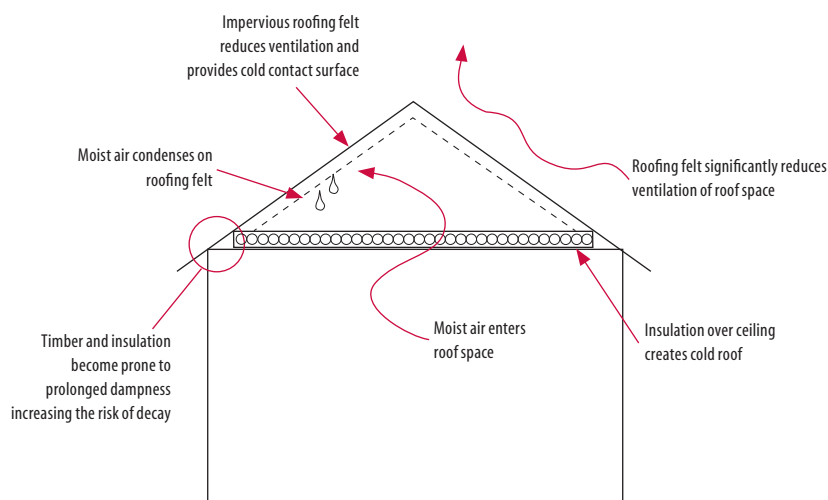
'COLD ROOF': simplified cross section of a building provided with insulation and roofing felt

- The introduction of insulation over a ceiling creates a 'cold roof' (see diagram).
- Roofing felt significantly reduces the air movement in the roof space.

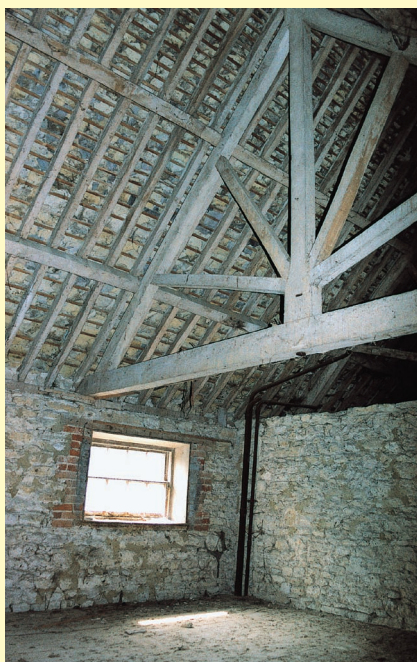
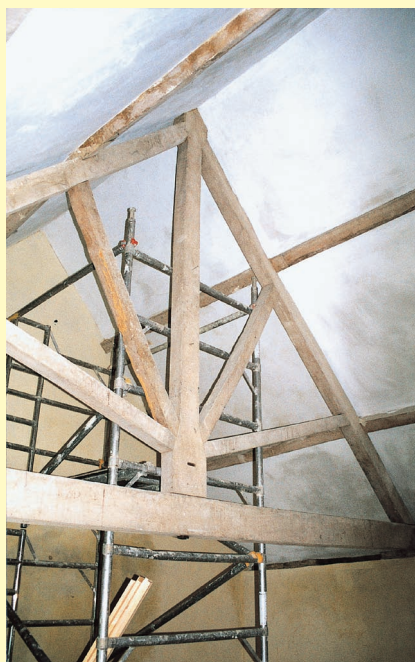
The roof before works implemented and, on the right, nearing completion

In this case the roof coverings, which consisted of stone slate to one slope and concrete tiles to the other, were to be left intact. The brief was to provide a finish suitable to accommodate the conversion of an unused upper floor 'loft' space and improve the thermal insulation.

In this case lime mortar torching to the underside of the roof coverings was used in the vernacular tradition to reduce the risk of wind-blown snow or rain. The subsequent risk of water penetration caused by loose or dislodged slates or tiles causing the torching to break down was mitigated by the use of a lightweight vapour permeable building paper to the underside of the rafters. The building paper also acts as a means of reducing draughts, which improved the effectiveness of the insulation. The disadvantage of this detail is that any water that penetrates the roof coverings could run down the paper and collect at the wallplate.

For this reason the client was made aware of the need for regular inspections and maintenance. Insulation was provided between the rafters with natural wool insulation and a lightweight mineral wool insulation board was used to provide a face upon which to apply two coats of lime plaster, which was subsequently limewashed. (An alternative to the lightweight mineral wool insulation board is the use of reed board, which is natural water reed held together with wire.)

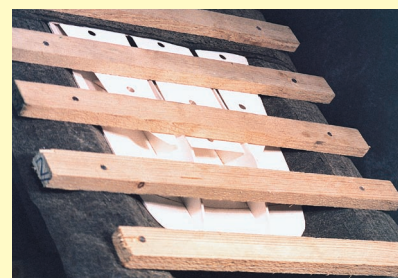
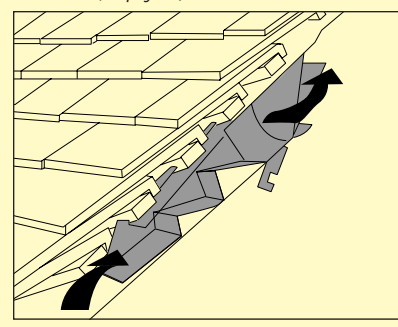
## A PROPRIETARY VENTILATOR NOT VISIBLE EXTERNALLY

One alternative solution to the problems of roof ventilation is the lapVent. Made from recycled materials, this simple ventilator is designed to maintain a constant passage of air between overlapping sheets of underlay. Unlike most modern roof ventilators, this one does not protrude above the roof-line (*see page 90*).
